Debris/Ice/TPS Assessment and Integrated Photographic Analysis of Shuttle Mission STS-63

(NASA-TM-110649) DEBRIS/ICE/TPS
ASSESSMENT AND INTEGRATED
PHOTOGRAPHIC ANALYSIS OF SHUTTLE
MISSION STS-63 Final Report, 1 Feb.
- 13 Feb. 1995 (NASA. Kennedy
Space Center) 102 p

DEBRIS/ICE/TPS ASSESSMENT
AND
INTEGRATED PHOTOGRAPHIC ANALYSIS
OF
SHUTTLE MISSION STS-63

2 February 1995

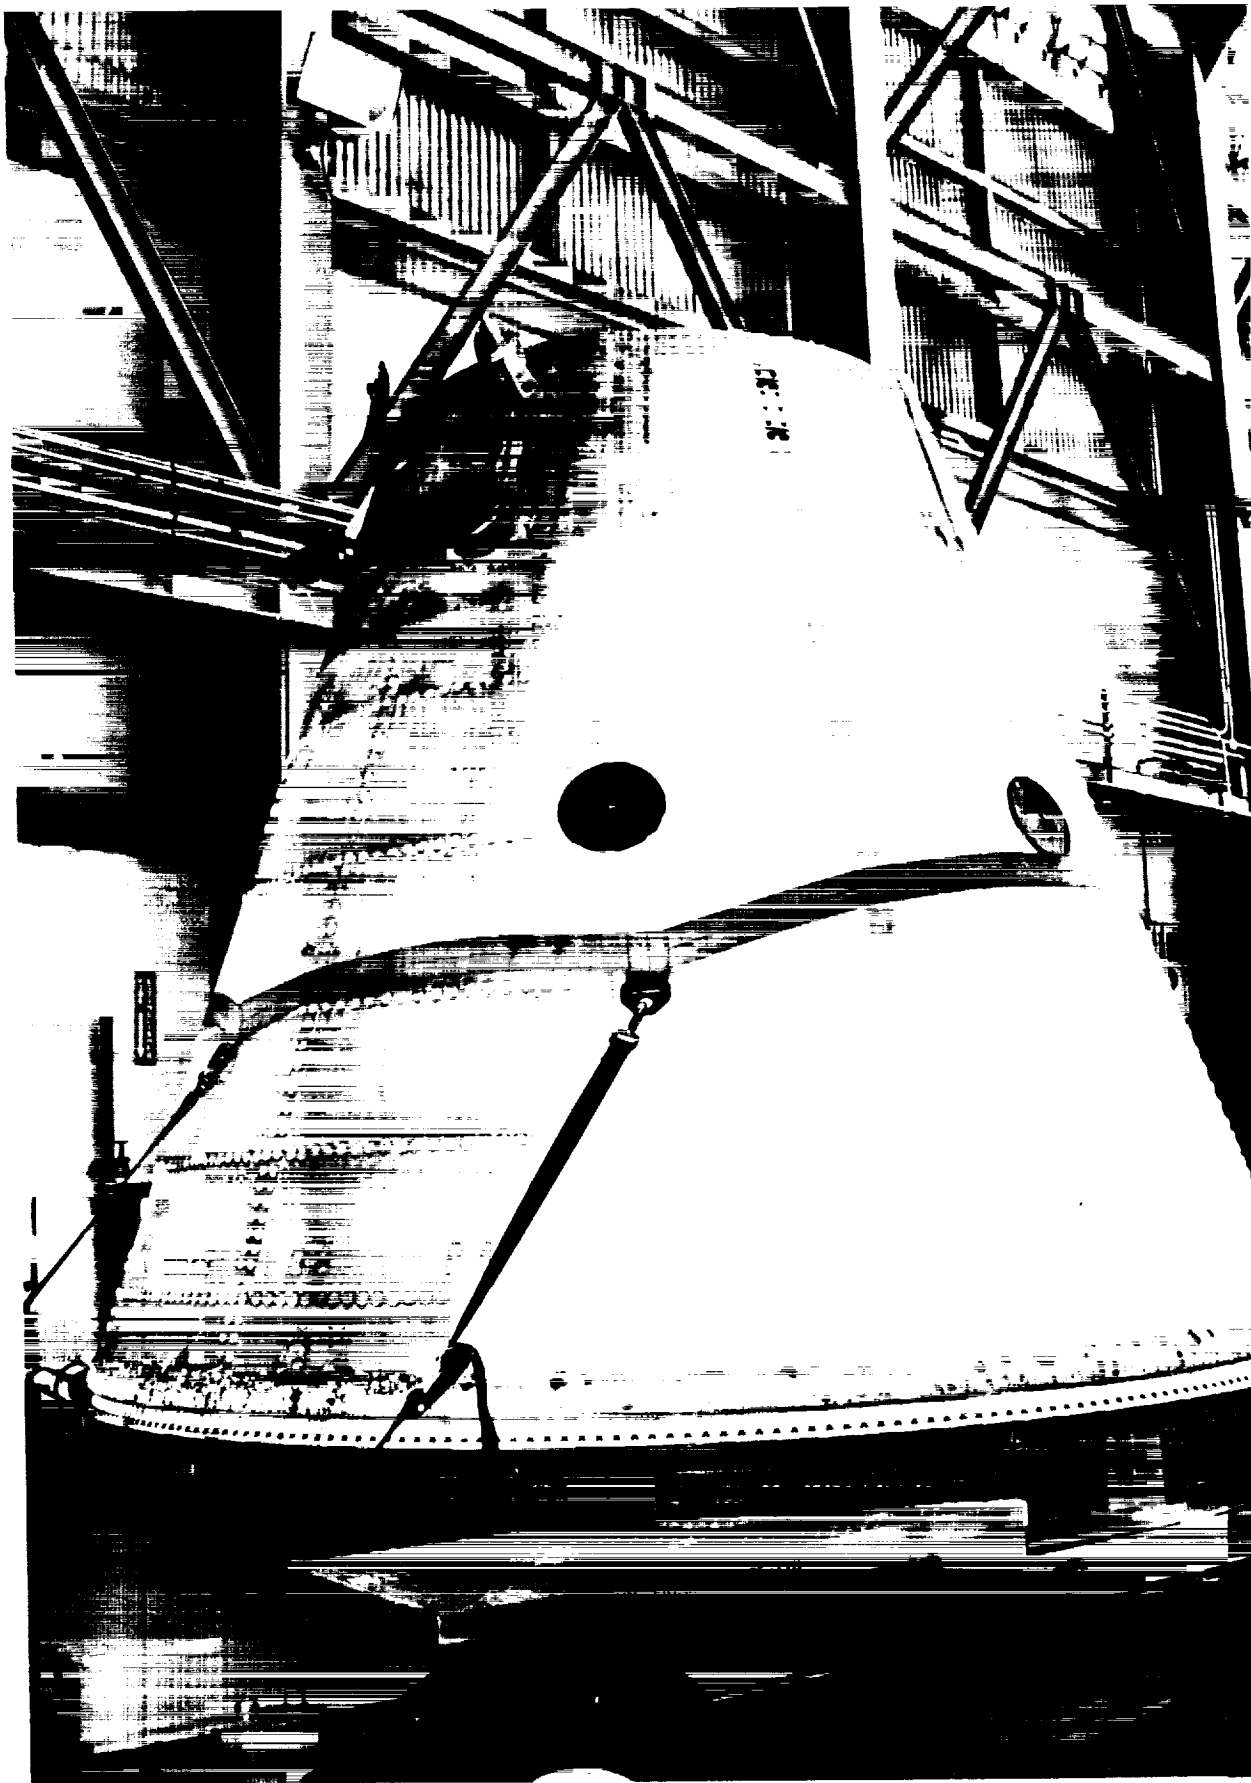
Photo 14 : RH Frustum

The RH frustum was missing no TPS but had 19 debonds over fasteners and 1 debond over acreage. Hypalon paint was blistered/missing where BTA closeouts had been applied along the 395 ring frame and around the BSM's.

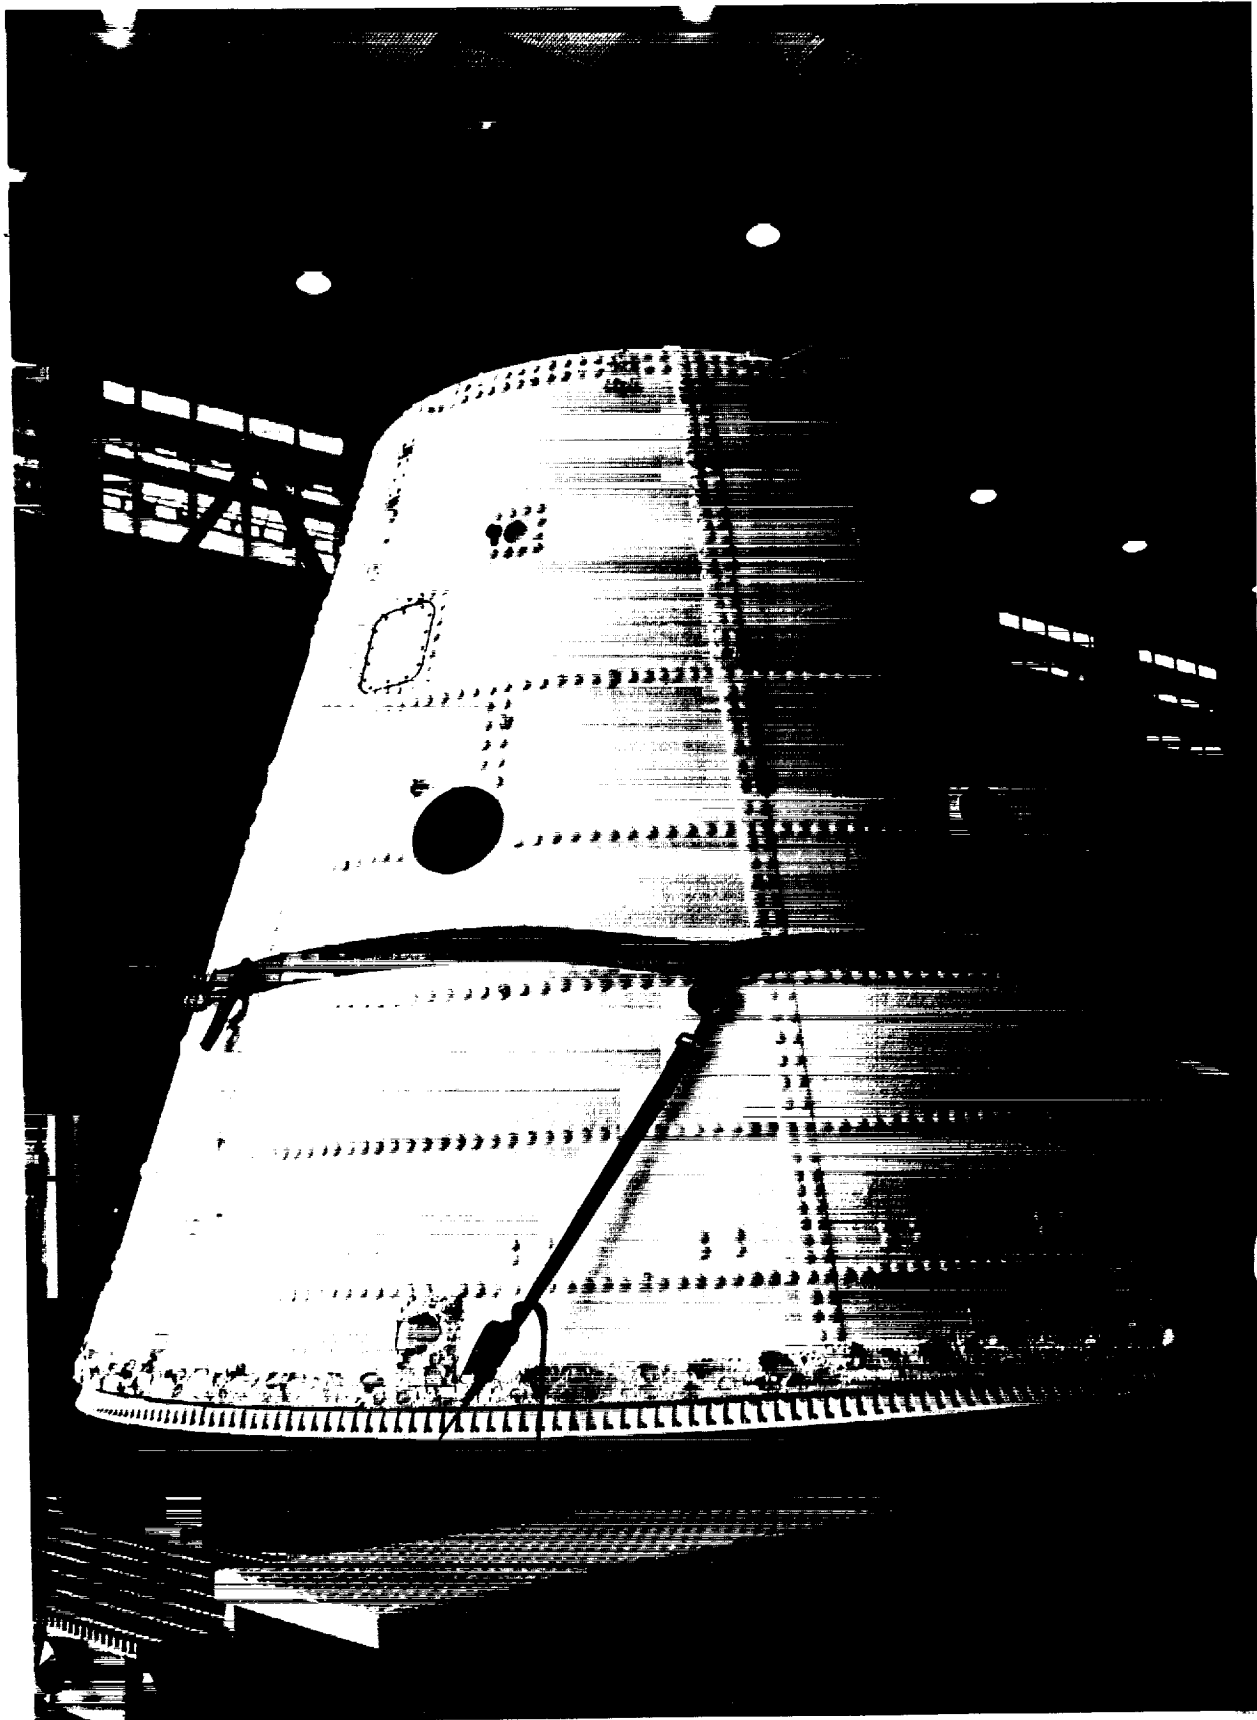
Photo 19 : LH Frustum

The LH frustum was missing no TPS but had 34 MSA-2 debonds over fasteners. Hypalon paint was blistered/missing where BTA had been applied along the 395 ring frame. Some of the underlying BTA was sooted.

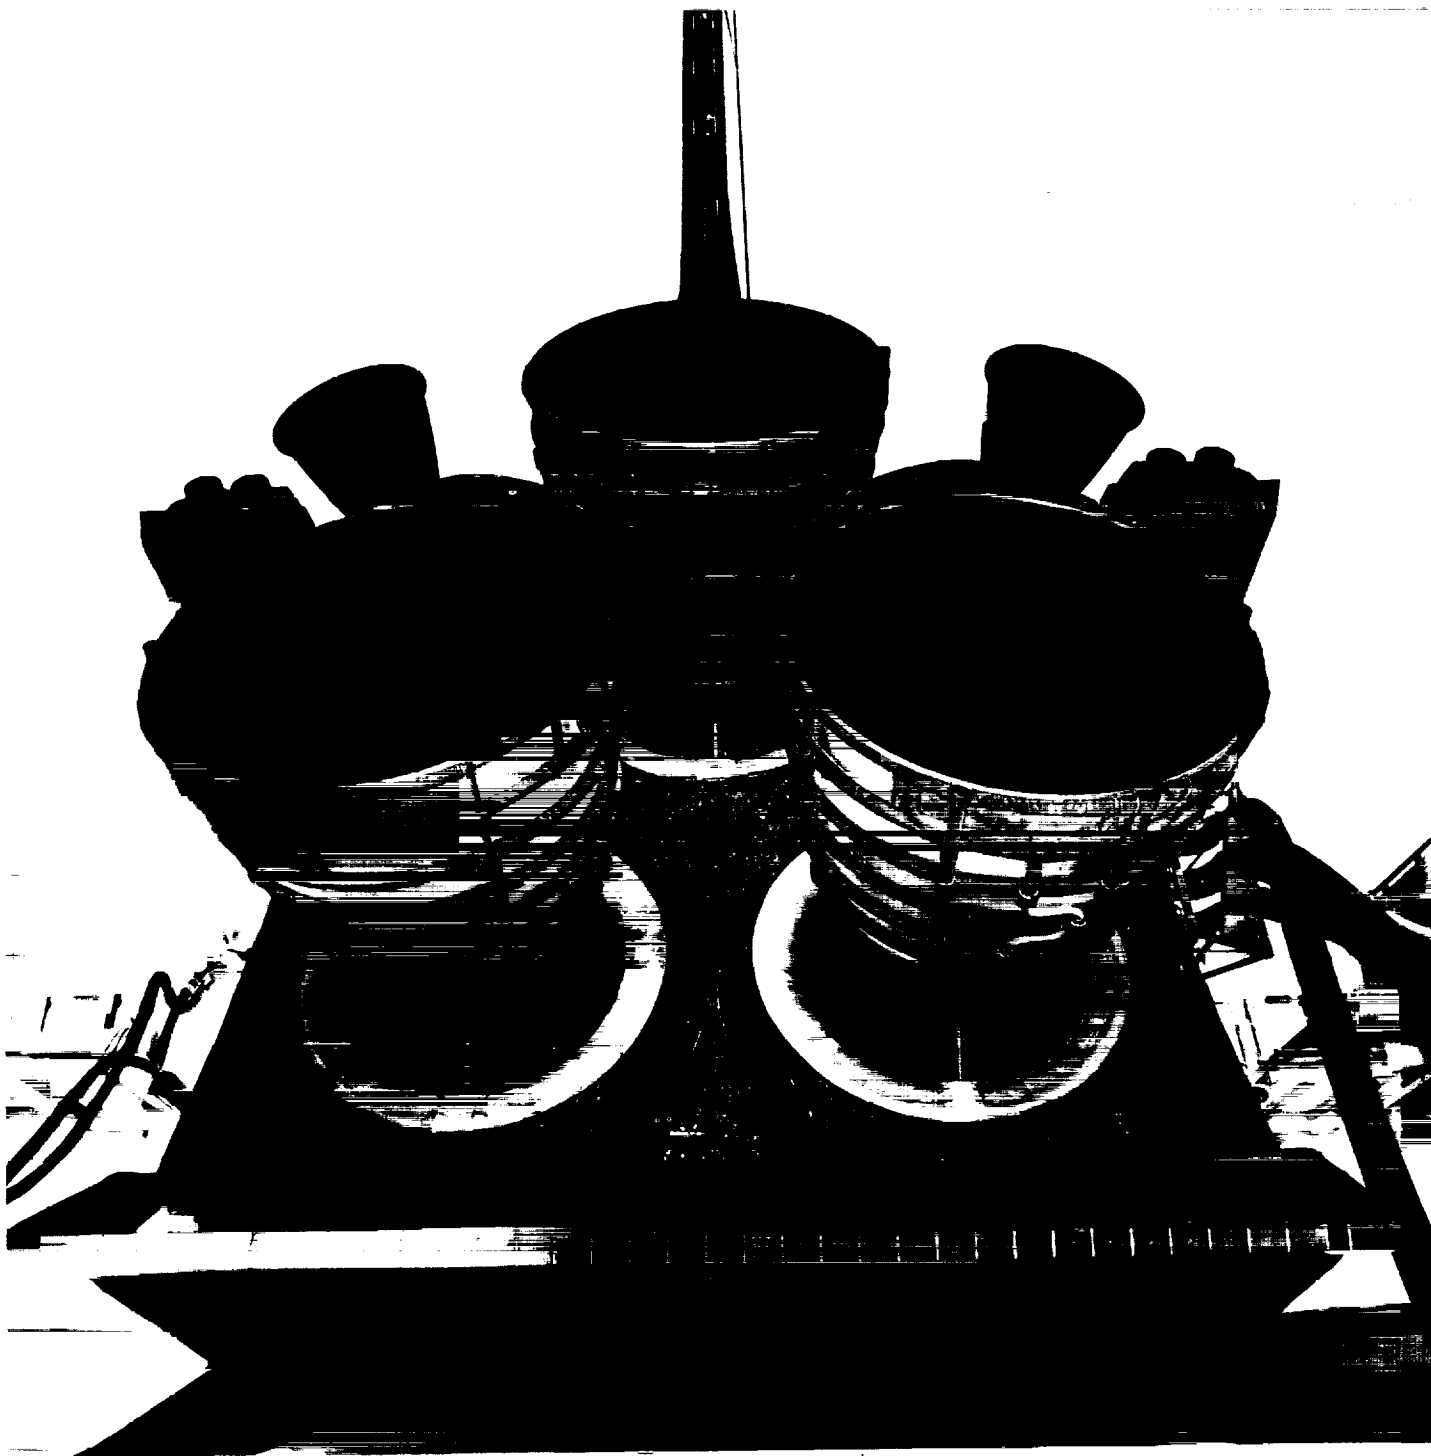
Photo 31 : Overall View of Base Heat Shield

Tile damage on the base heat shield was typical with the exception of a damage site that involved three tiles between SSME #2/3 and the body flap hinge. Dome Mounted Heat Shield (DMHS) closeout blankets were frayed/ripped on SSME #1 at the 6 o'clock position and torn on SSME #2 at the 3 o'clock position.
